# Rebuilding The Mast of a Gunter-rigged Westerly 22

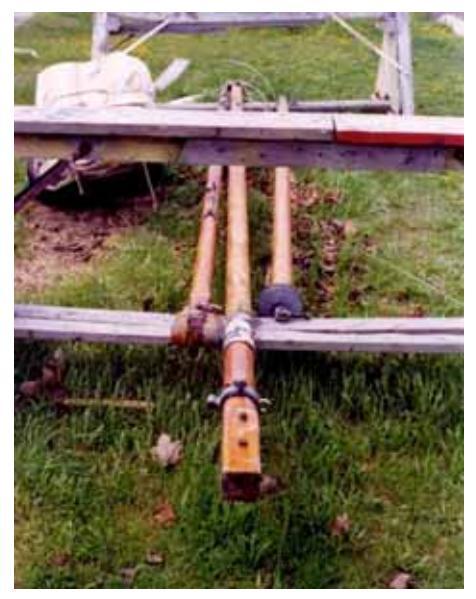
The varnish was very poor or absent, the jaws on the gunter boom were broken and the remaining ends were worn stubbs. They had been replaced by an interesting combination of plastic drainage pipe and light metal strapping (note image at left) that was supposed to slide up and down the mast. The wire that ran along the Gunter

spar for raising it and sliding the it into position was sound but the spar itself at the attachment points was very cut up and damaged the through bolts were severely bent inside the spar and the outer end was held together with an expansion clamp (note left). The main boom

The jaws were a mess (Note picture at beginning). I spent a fair bit of chasing on the Internet worrying over size shape construction etc. I even considered replacing them with metal ones I found at Classic Marine in the UK. In the end I decided to rebuild them with some oak I had on hand. I cut and shaped new sides and then glued them to the original remaining stumps. Once they were properly shaped I glassed and epoxied a couple of layers onto each to provide strength and stability. The plan is to leather the insides before I put it aboard. I have not yet remade the small wedge that slots down between the jaws and the mast. I am considering putting a small roller at this point instead. I will also secure the jaws to the mast with parrel beads.

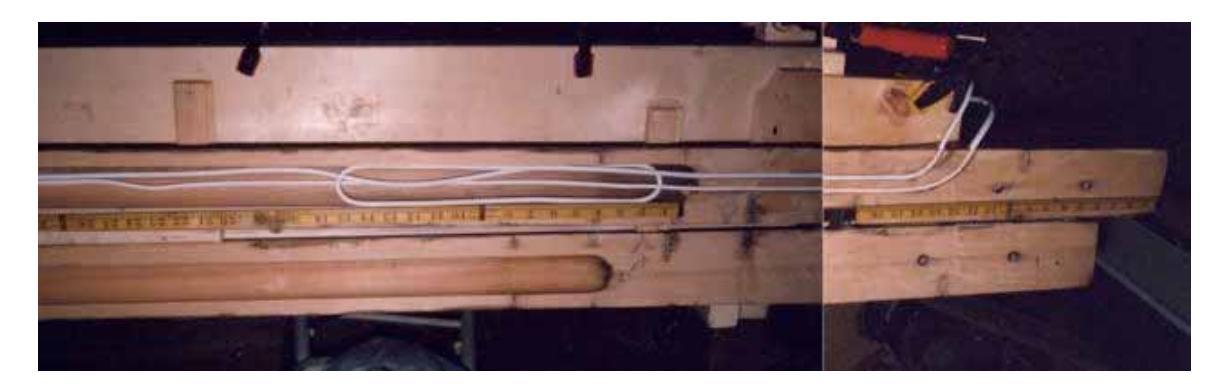
This picture shows the lower section of the mast with the wires in place. The large loop is in the coaxial cable. I also placed a smaller loop in the electrical cable. The purpose for this was so that if

needed, I would have extra wire available whenever an end fitting was needed to be replaced, or if wire was damaged. I really did not want to split the mast a second time. I also angled downward the router cuts where the wires exited the mast. Note also that all the routering was just large enough for the wires to be able to slide and that only the starboard side of the mast was routered.

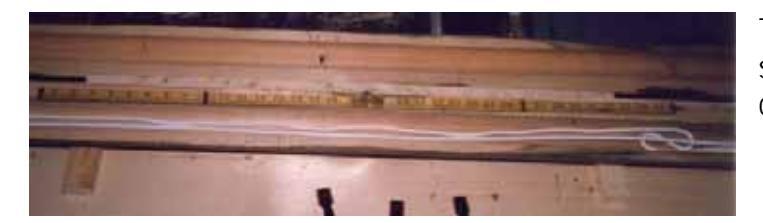
This shows the mid section with the smaller loop visible in the electrical cable.

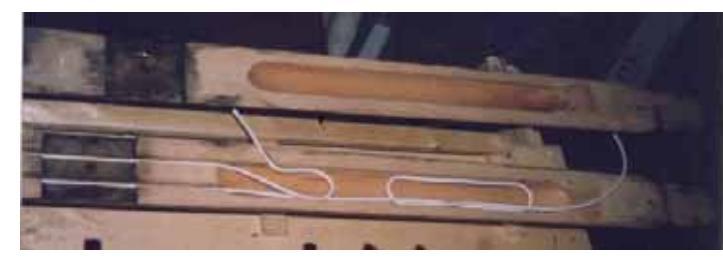
This shows the upper section of the mast and how the wires were passed through the sheave area and then led out of the mast. Note also that I put loops at this end as well for the same reasons as in the lower section. With the wires

bonded at the sheave this allowed access to pull out extra wire to repair fittings. In the photo its not so clear, but there is a distinct downward turn where the VHF cable leaves the mast. The wire for the steaming light is clearer. Where the wires passed by the sheave they were bonded in place with a flexible sealant. The wood was sealed with epoxy before they were laid in place.

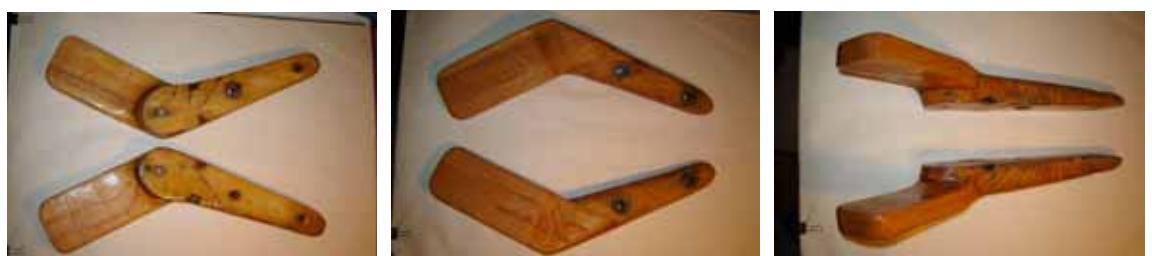
Here are the jaws ready to be assembled on the boom. If they break again I will replace them with a set of metal Gunter jaws that will allow for twist, which I believe is the primary reason for breakage.
