Replacing Foam Backed Vinyl Headlining

Roger Clark
Fulmar Concerto FR38

Westerly Owners Association East Coast Group Zoom Clinic 24 February 2021

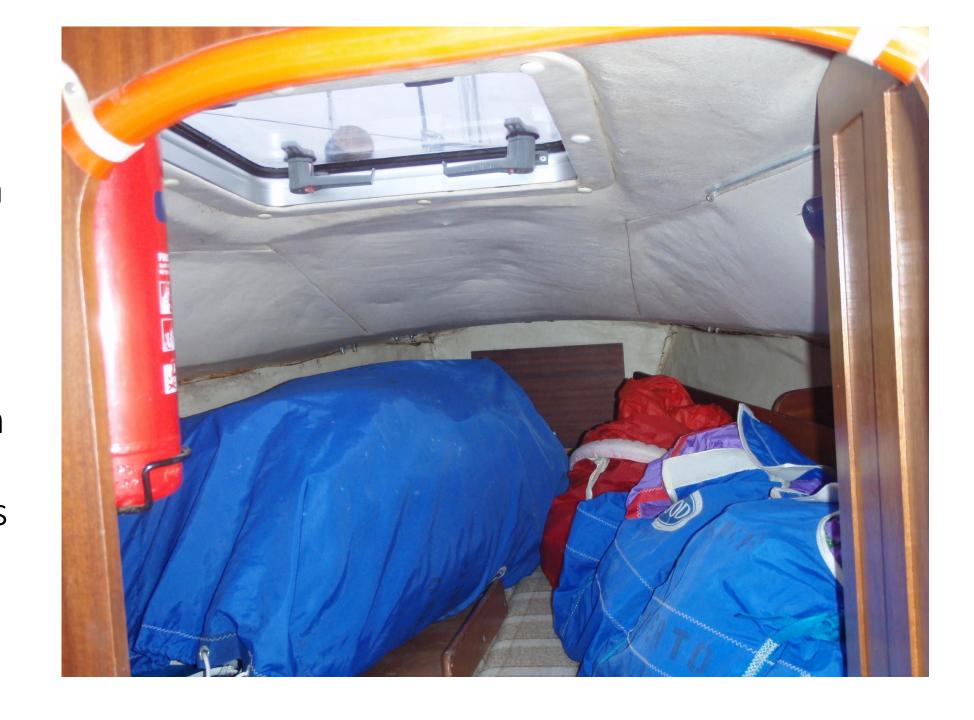
Concerto's forward cabin when bought in Dec 2013. The headlining was in a poor state and had previously been reglued. Foam backed vinyl has a typical life of 25 to 30 years.

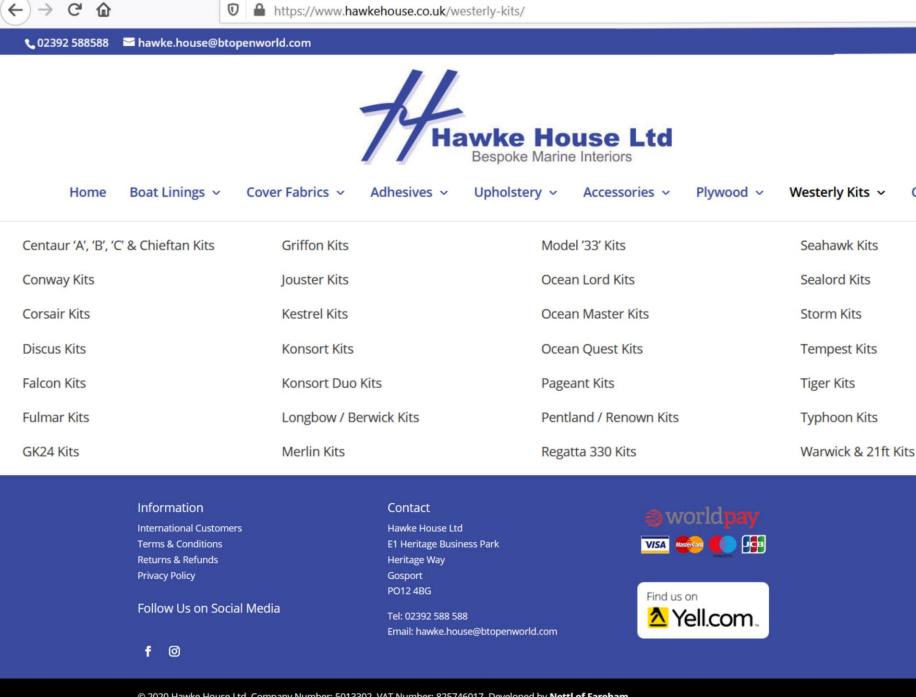
Bespoke kits are still made by the original supplier to Westerly, Hawke House. These are the models they have patterns for stitched parts, plus they supply in roll form and adhesives, etc.

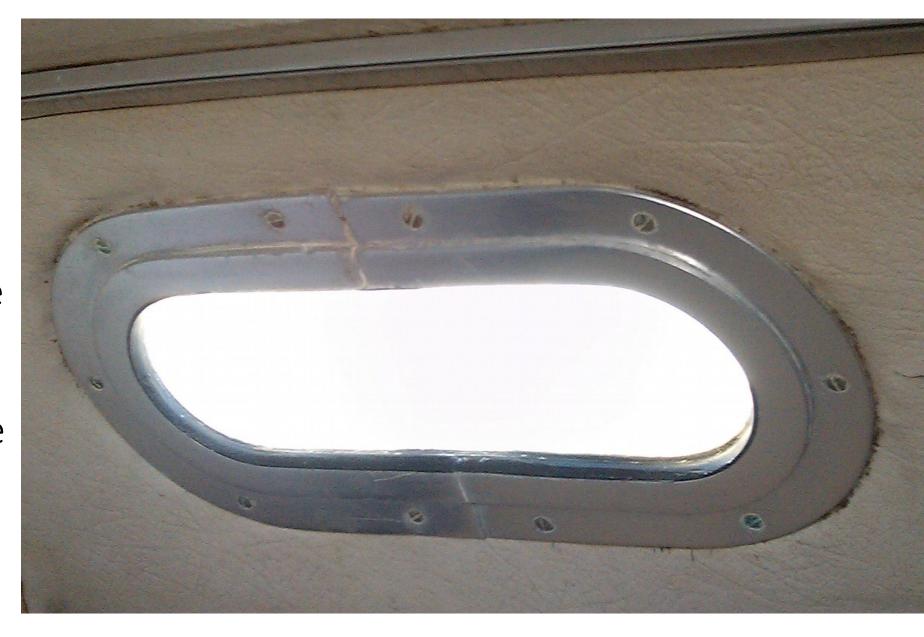
Removal of the existing headlining does involve removing some wood trim and window trim. You can just remove the inner window trim to save taking them completely out. The old foam will be quite dusty but is easy to sweep or vacuum up.

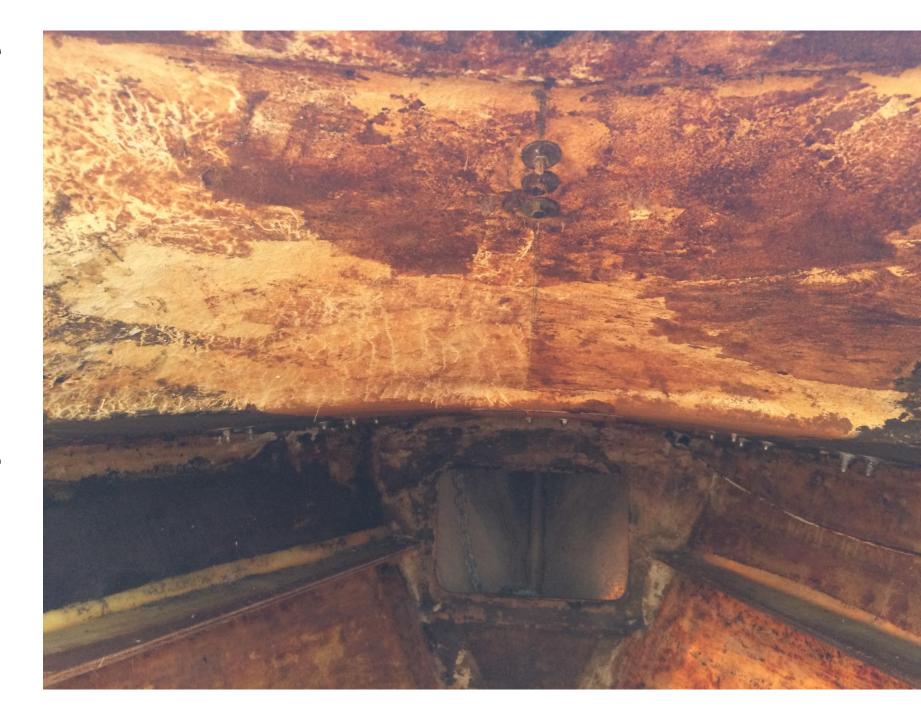
This is what you are left with, it looks a mess. You do not need to remove all the old adhesive, just make sure there is no old foam left. The upper port hull side still has old foam. Scrap it off and leave no lumps of old adhesive.

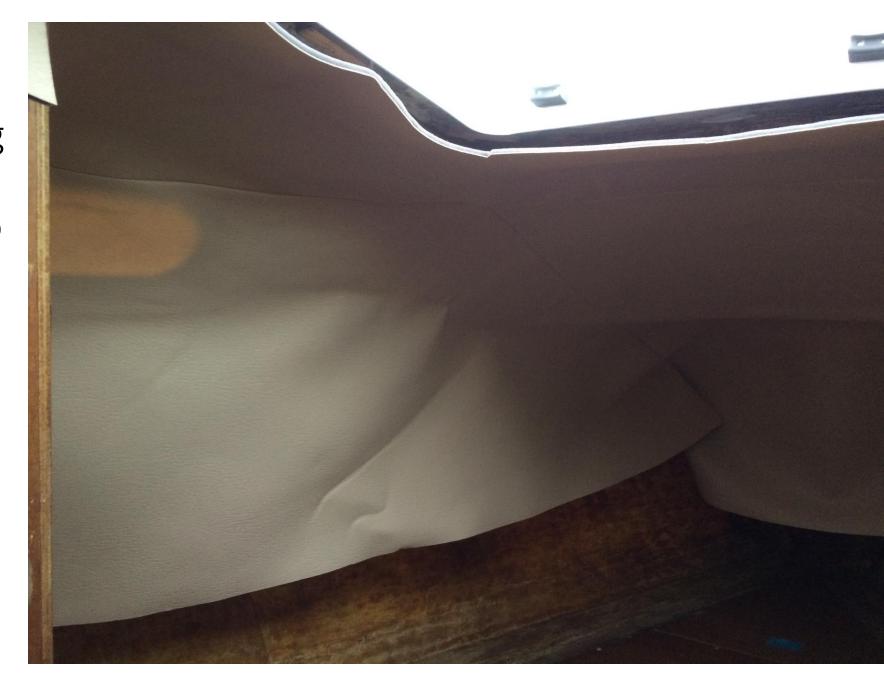
The center line of the coachroof was already marked, along with the new vinyl to assist in alignment. To start you work a strip about 6" either side of the line and progressively work outwards.

The coachroof and sides have been bonded here.

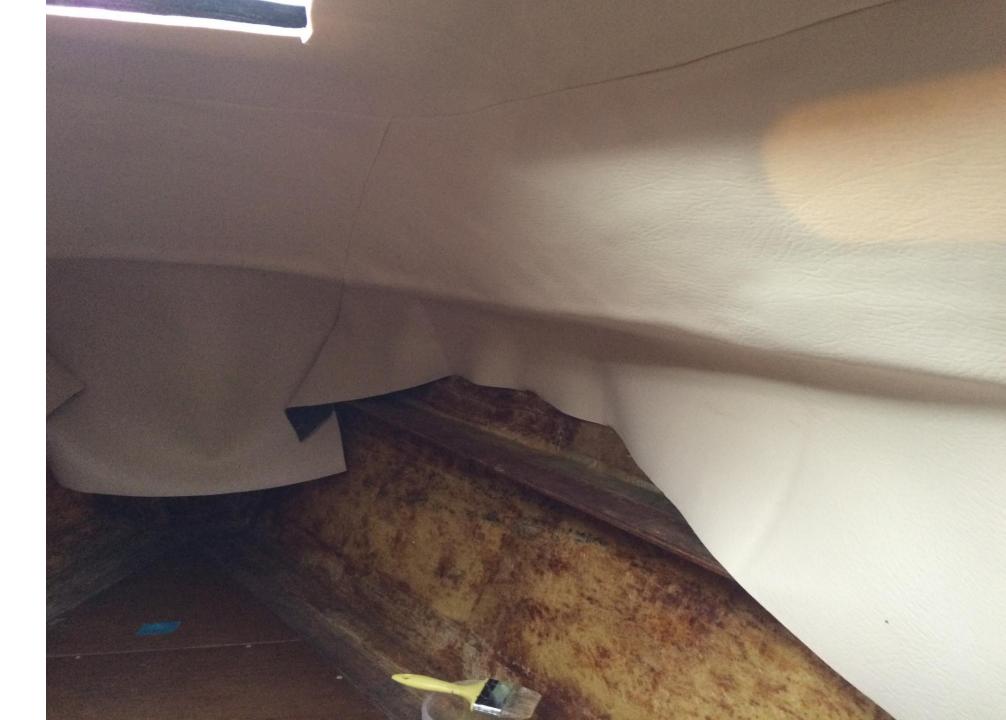
Progressively working to fix the headlining under the side decks.

Do make sure the cabin is well ventilated or you will get a little high on the petroleum based fumes.

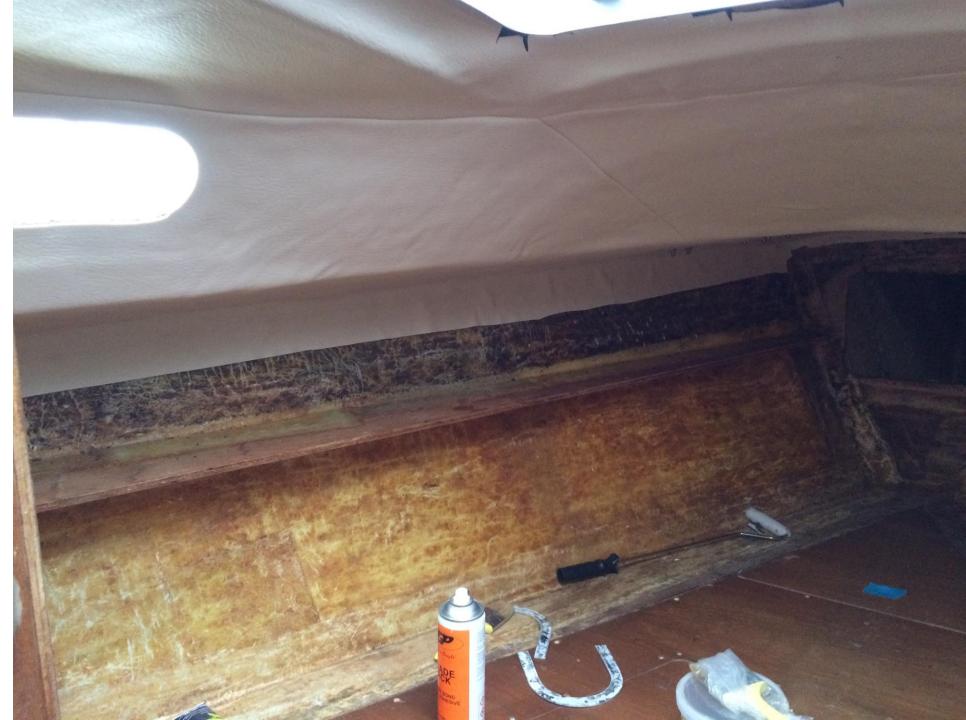
Now fix a strip down the hull about 4" wide. It is best to remove the foam from this strip.

You can see the spray adhesive can and the small paint roller used to gently push the foam vinyl to bond.

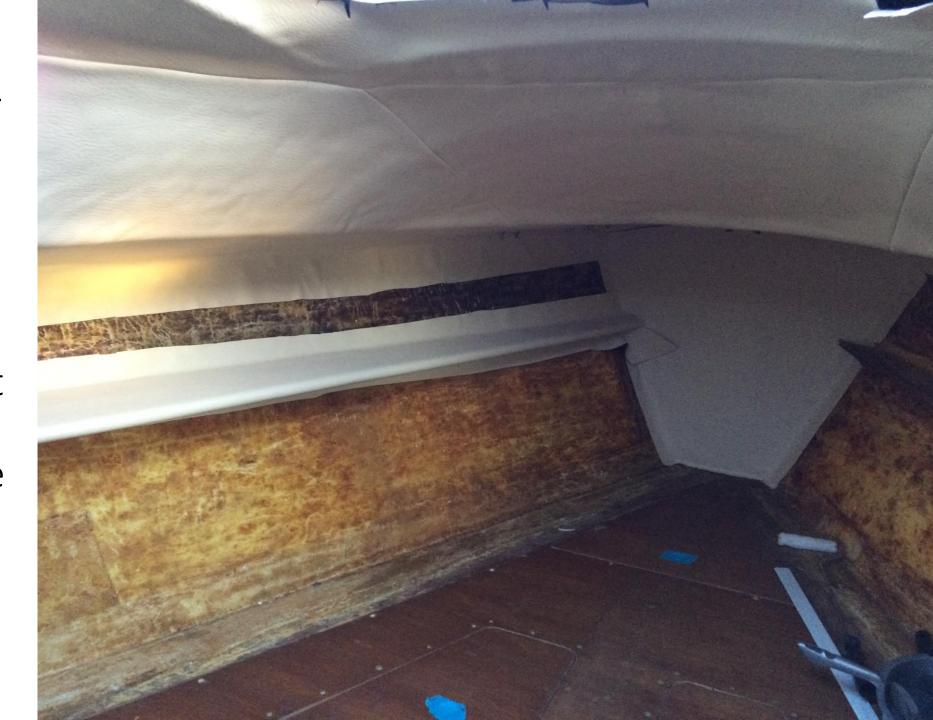
The anchor locker bulkhead has been covered and the port shelf. Wrapping the shelf is made easier as the front edge is straight. Again, remove the foam from the vinyl lip fixed to the hull.

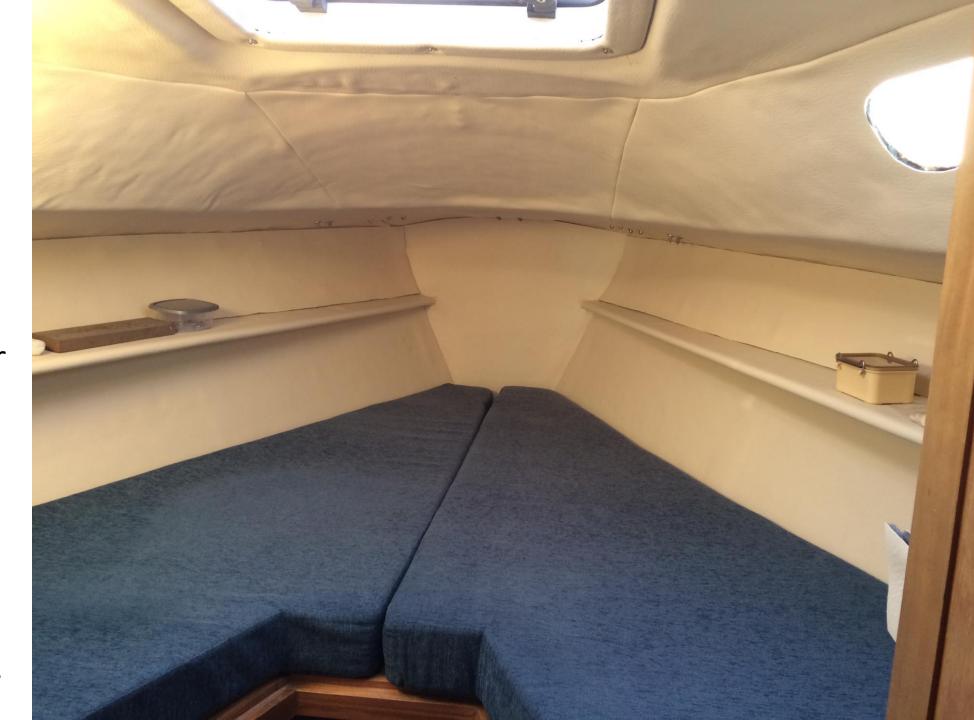
This is the finished cabin before the wood trim, windows and curtains are refitted. It looks so much brighter now.

Most of the small ripples will relax out over a couple of weeks.

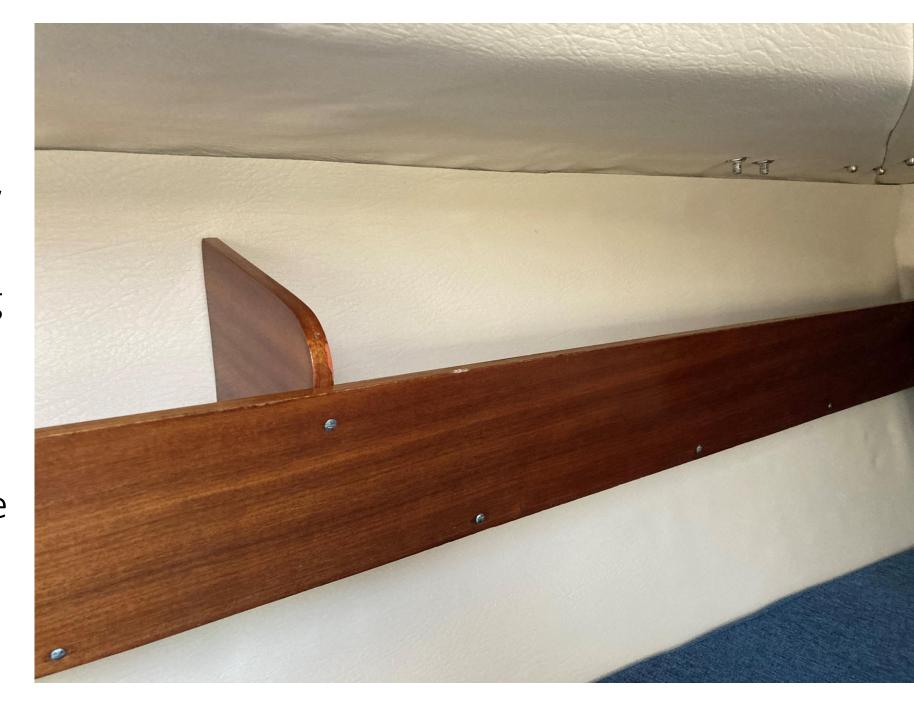
The port shelf has been relacquered before being refitted. Notice how neat the cut at the top of the hull lining is. A snap off knife and a steel ruler were used to just cut the vinyl, not the foam. Once cut through, it was glued in place.

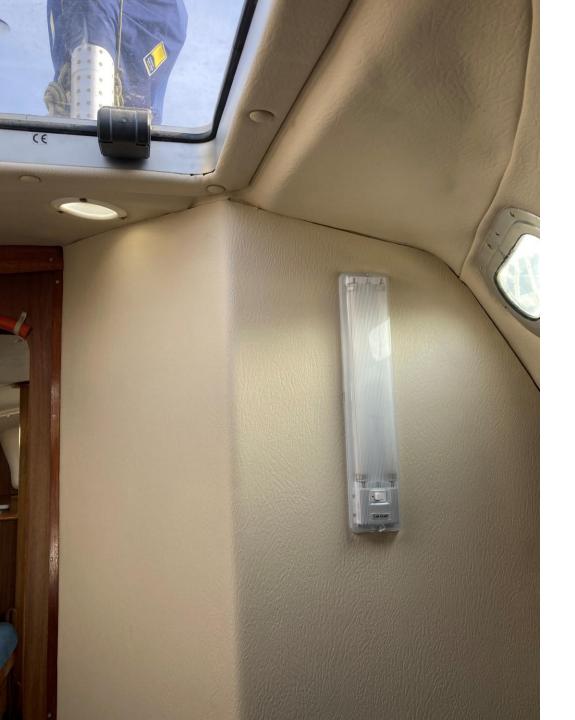
The bulkhead in the forward cabin has been recovered. The galley headlining was completed by the previous owner.

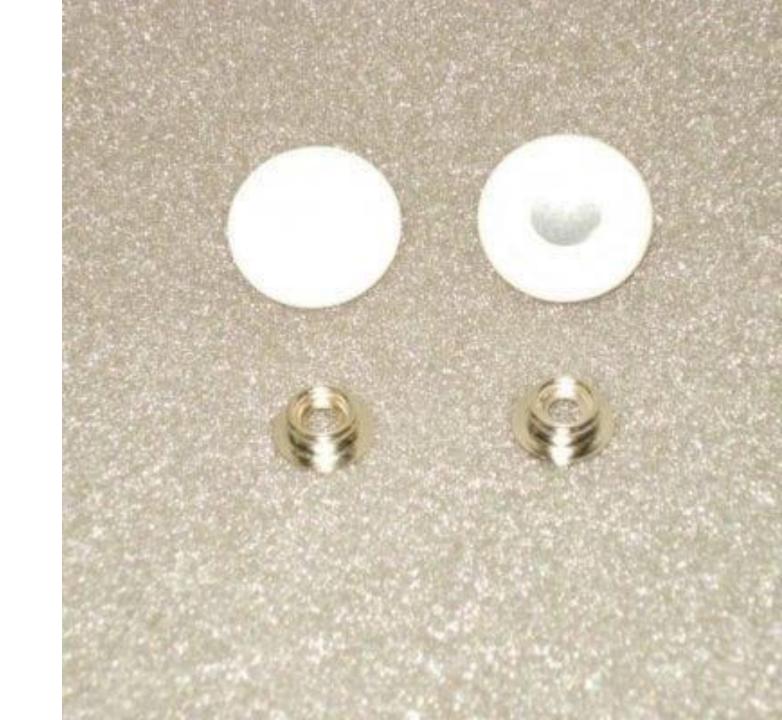
For headlining panels and the trim round the forward hatch, these are best if screwed in place. These buttons and studs are used to hide the screws.

Any excess vinyl from the job can be used to line your lockers.

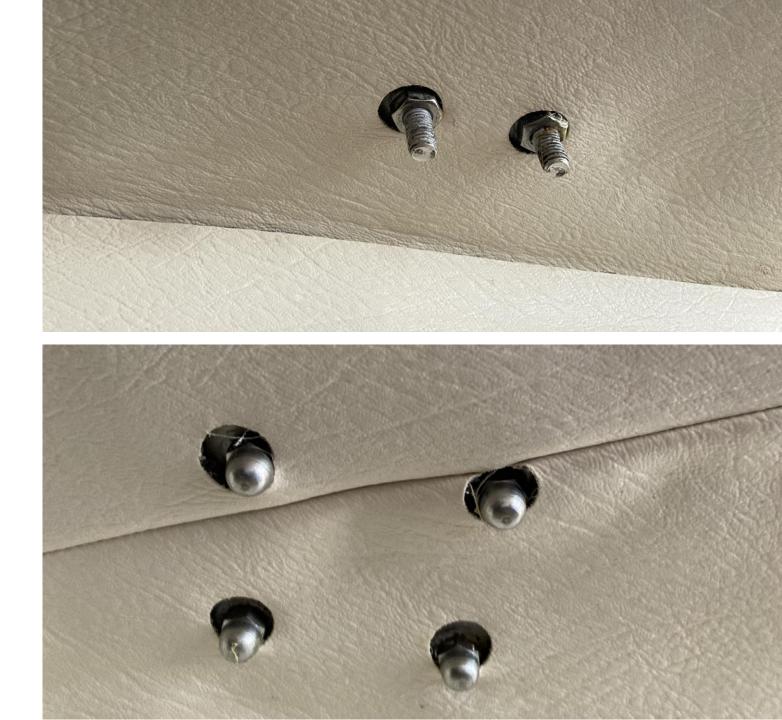
One other thing I did was to allow access to any exposed nuts from the stanchions, side cleats and anchor winch. I used a large hollow punch for leather to cut holes in the headlining.

Keeping a watch for water leaks is important as it can start the breakdown of the foam in the headlining.
