Westerly 22 rudder design

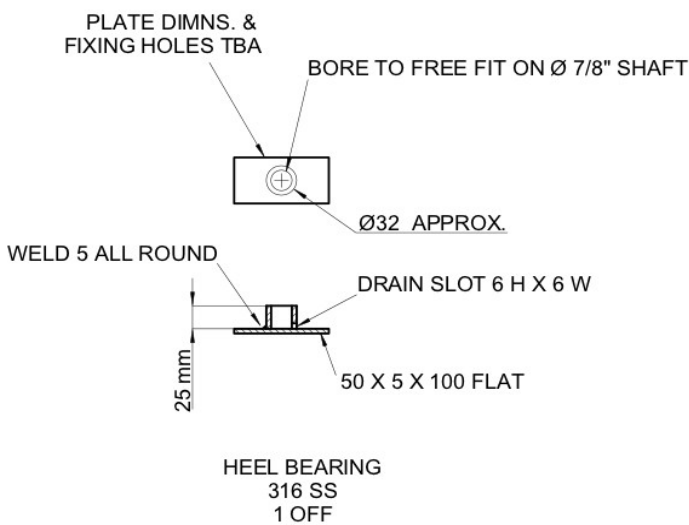
The heel bearing.

The heel bearing was never used as the bottom of the bar slotted nicely into the existing foot on the skeg.
