## Fitting a Bowthruster in a Konsort Duo

(- or any other boat for that matter).

Westerly Konsort Duo 29, "Oyster" \*

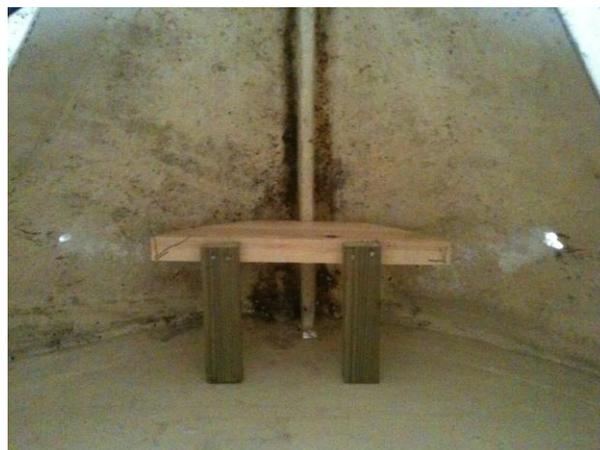
I had a template to show me where the centre of the tube would be - both vertically and horizontally - I then placed a strong magnet on this spot, and had a minute compass on the outside to show where the tube would go. Next step was to tentatively drill a minute (1mm) hole through the hull to show exactly where it would be on the outside. Satisfied, I opened up the hole to 6mm.

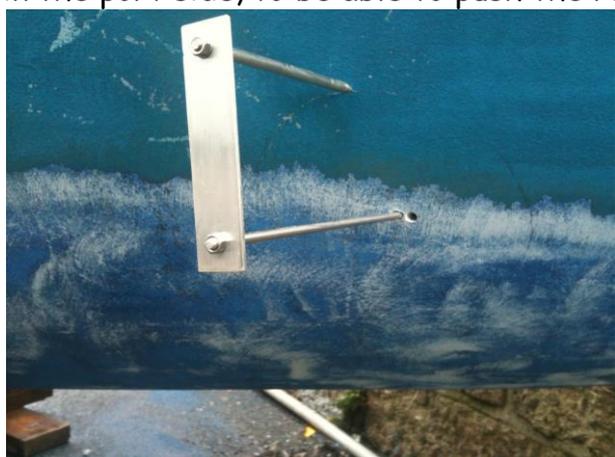
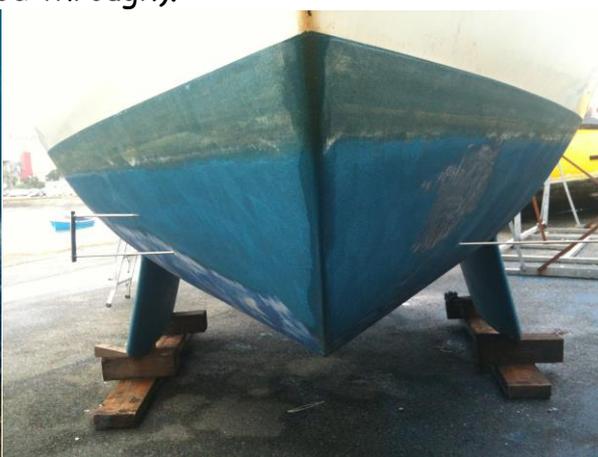
Next step was to mark out the hole on the curve hull. I made a scriber from a long length of 6mm SS and pushed the rod through both port and starboard holes. Scribing on a curved hull gives a most strange "round" hole. (The second hole was to allow me to see the hole in the port side, to be able to push the rod through).

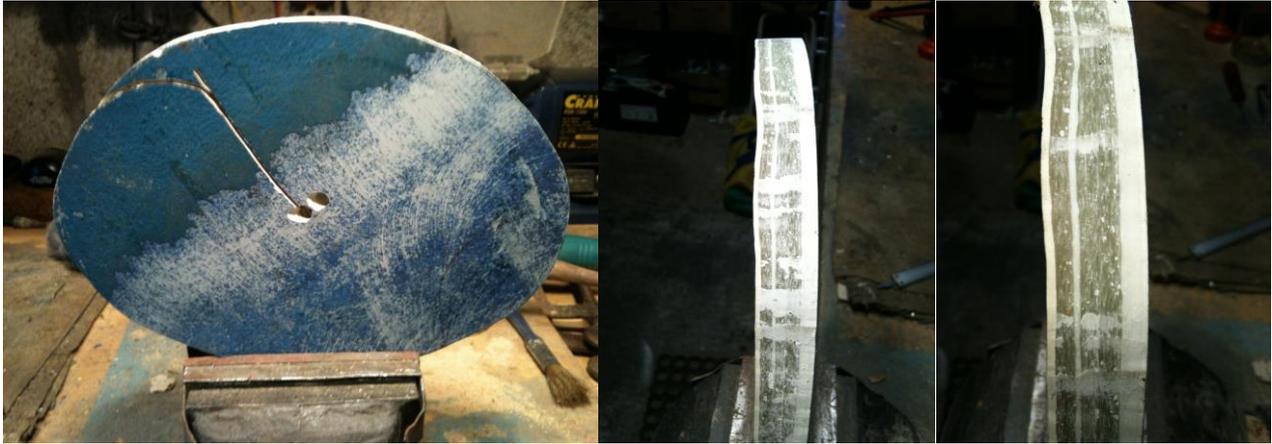
Cutting out the hole shape was by a jigsaw with the ability to cut to an angle. This allowed me to cut horizontally at the top and sides of the hole. Even then, I had to open it out a bit to allow the tube to go through. Note the shape of the section removed, and the difference in thickness of both sides of the hull.

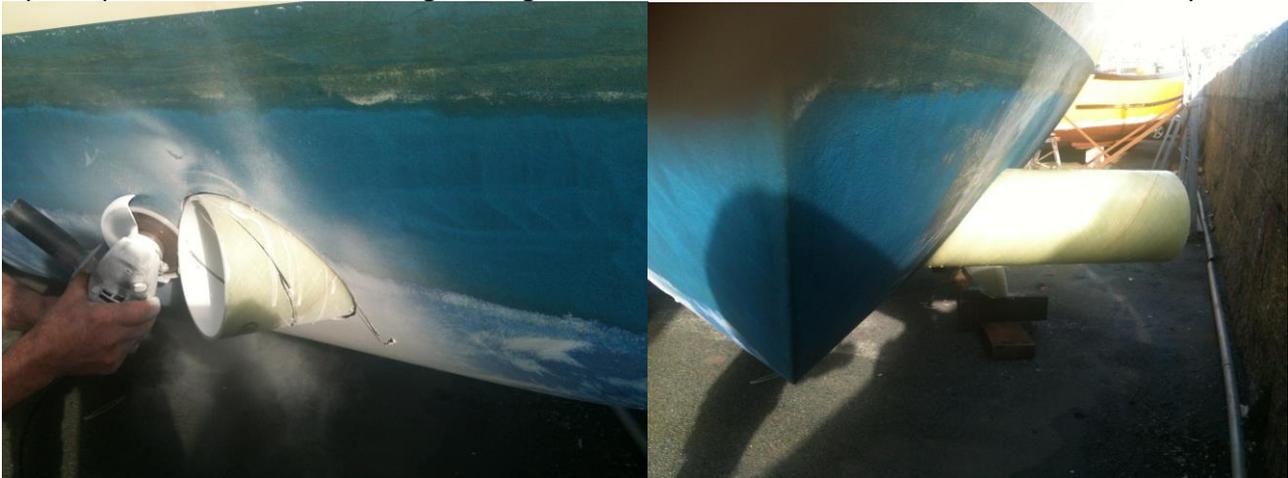
I then had to grind off all gel-coat from inside and outside to about 3 or 4 inches from the hole, or as far as I could when coming against the bulkhead. What an absolute mess I made of the fore-cabin - and me! Gel-coat dust was blowing out of the tube holes and top hatch like smoke!

Once the tube was in position, it was cut to rough length, then glassed into position with about 6 or more layers of matting, to equate to the thickness of the hull and tube. There was plenty of ventilation while glassing, with the cabin door and all hatches wide open.

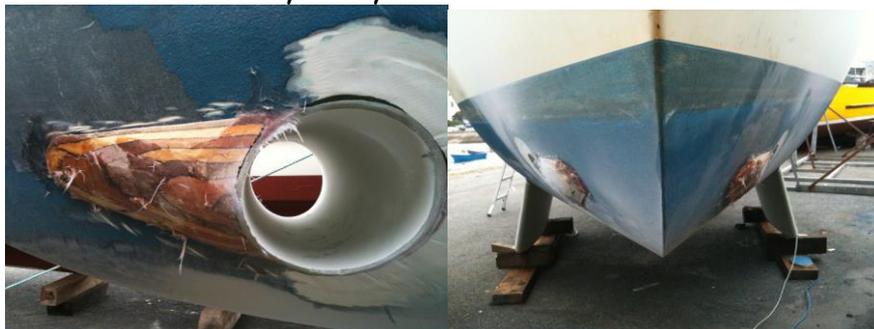
Outside, the leading edge of the hole was built up using a plywood filler, and then glassed over to allow the hole to be more hydrodynamic.

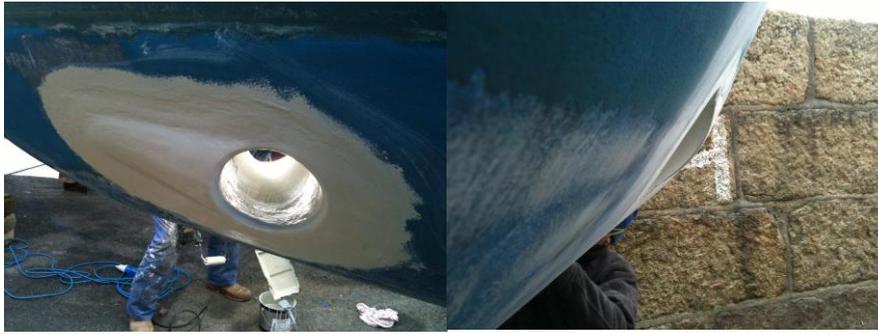
Before fitting the motor/leg unit, the tube was primed and anti-fouled using normal hard (i.e. not self ablating) A/F. (It might look a bit rough in the photo, but this was faired, once the irregularities were seen).

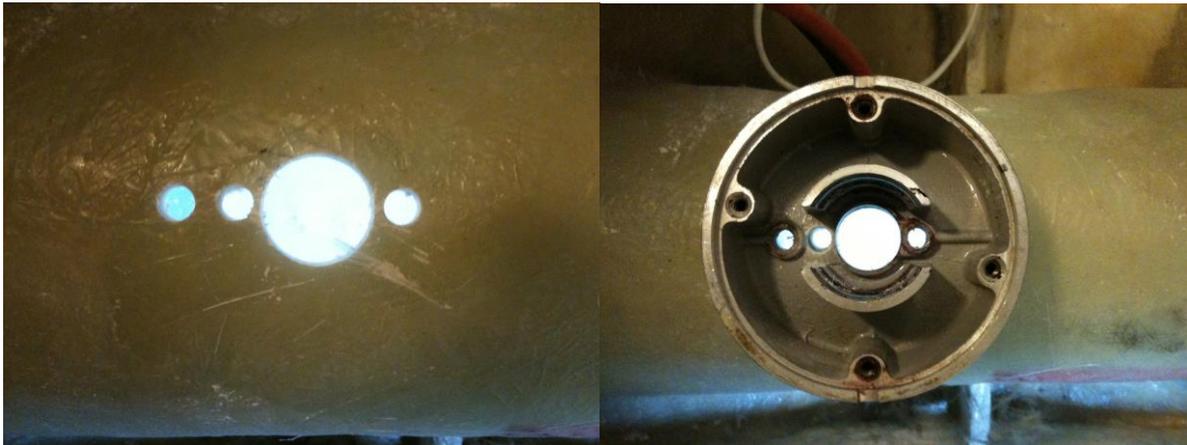
Marking the position of the thruster motor was by template, to show where to drill the bolt and drive holes.

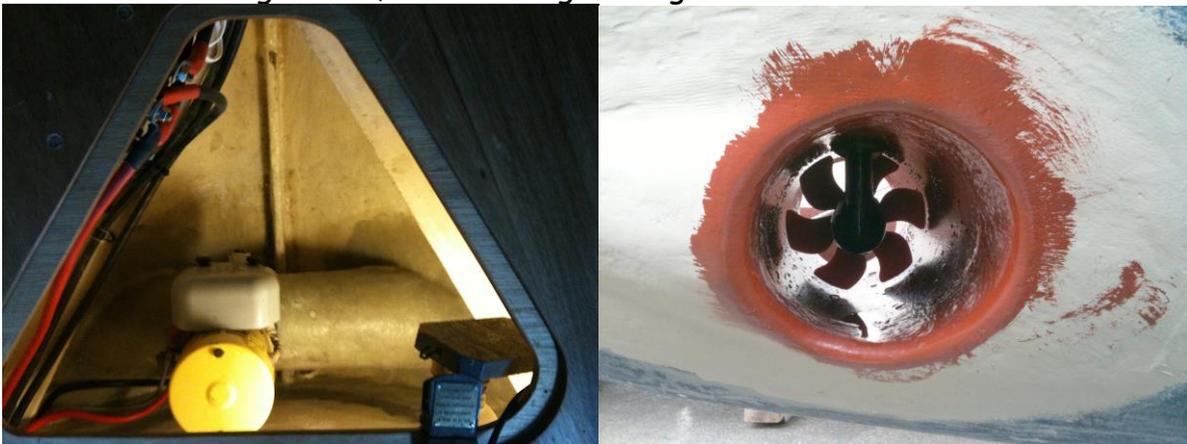
Liberal use of sealant was given to all the sealing components - bottom leg, seating flange and gaskets. The leg and motor were then bolted together - not tightly until the next day to allow the sealant to go "off", and then tighten against the set sealant.

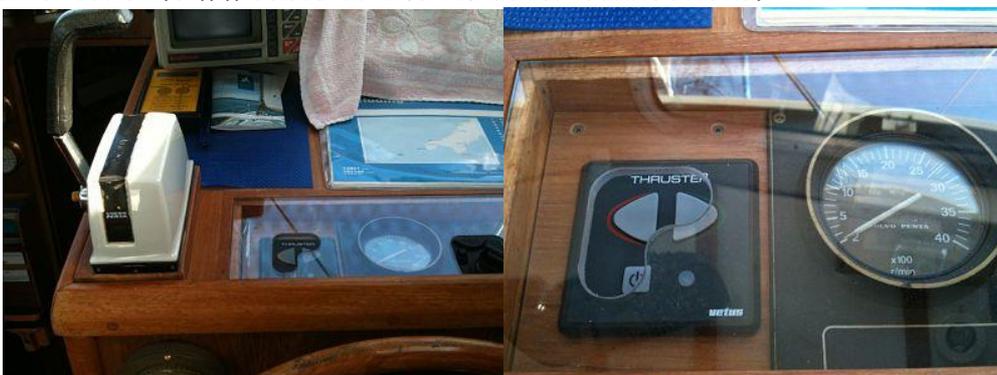
I fitted the thruster controller into the inside helm position, next to the engine start panel, and ran 3-core 1.5mm cable to the thruster connections.

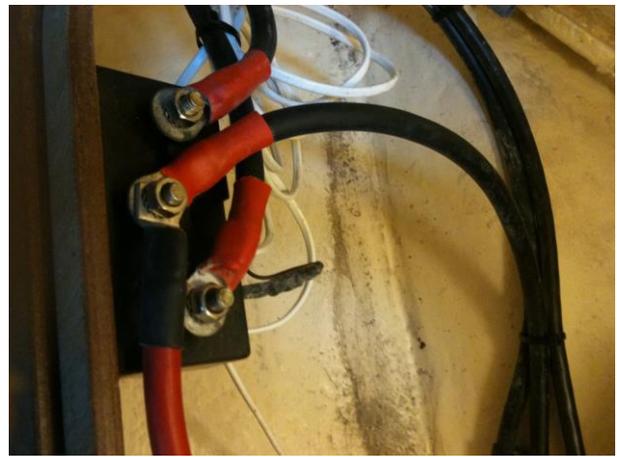
12volt power for the thruster is shared from the windlass power supply, supplemented with a 12v 85Ah battery close-by. The reason for this was to allow the original windlass breaker to be of use for the windlass and thruster, but was not big enough for the thruster on its own. The battery then supplements the supply. Another breaker protects the thruster. It all works as I hoped it would.
