# Rebuilding The Mast of a Gunter-rigged Westerly 22

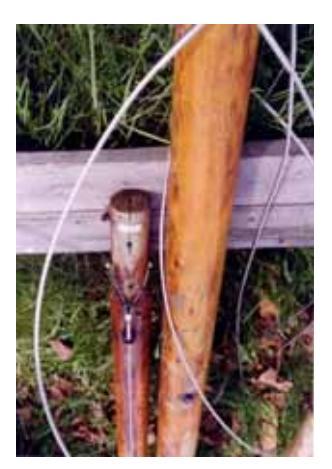
The varnish was very poor or absent, the jaws on the gunter boom were broken and the remaining ends were worn stubbs. They had been replaced by an interesting combination of plastic drainage pipe and light metal strapping (note image at left) that was supposed to slide up and down the mast. The wire that ran along the Gunter

spar for raising it and sliding the it into position was sound but the spar itself at the attachment points was very cut up and damaged the through bolts were severely bent inside the spar and the outer end was held together with an expansion clamp (note left). The main boom

was lacking in finish and the sail slot was split and broken at the foot. The metal fittings were all in very good condition and the roller furler was rust free and well greased. The mast itself was structurally

sound albeit with several large areas of glue failure along the seams. The Resorcinol glue would have been nigh 40 years old at that point, so given the level of care I would say it had proven itself. I chose to replace it with epoxy as I am more familiar with this type of glue and its gape filling qualities are more forgiving of small gaps and imperfections.
